D3.2 Flight Test Report Phase #1

Julius Bartasevicius (TUM) and Sebastian Köberle (TUM)

GA number: 815058
Project acronym: FLIPASED
Project title: FLIGHT PHASE ADAPTIVE AERO-SERVOELASTIC AIRCRAFT DESIGN METHODS

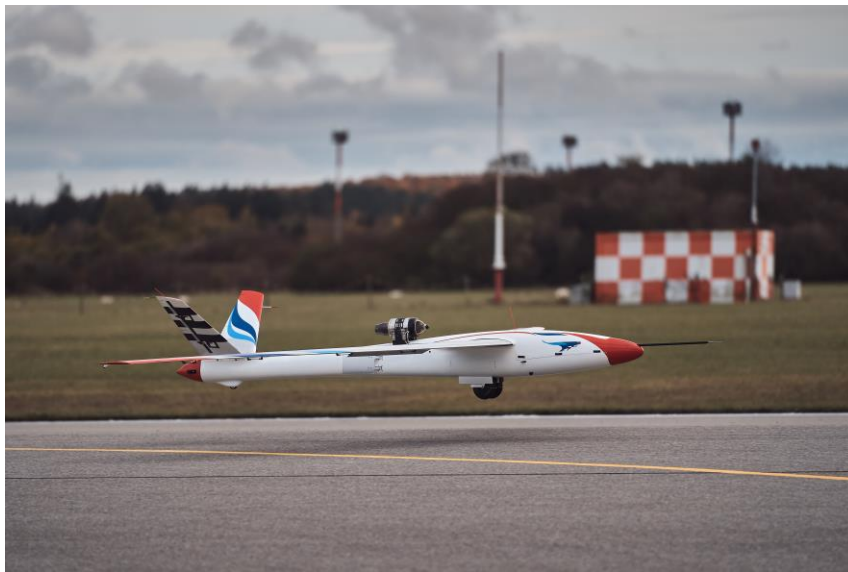
Figure 3 - T-FLEX Demonstrator during the last flight within the FLEXOP project.

The project for TUM has started with a demonstrator, which has already been used in the previous project, FLEXOP. The demonstrator has performed six flight tests up to then. However, building on previous experience, landing gear proved to be one of the biggest challenges during the operation of the demonstrator. The aircraft was very difficult to control while on the ground, leading to a few very dangerous situations and one accident, where the aircraft skidded off the runway and hit a runway light. Therefore, upgrades were necessary to ensure sustainable operation of the aircraft.

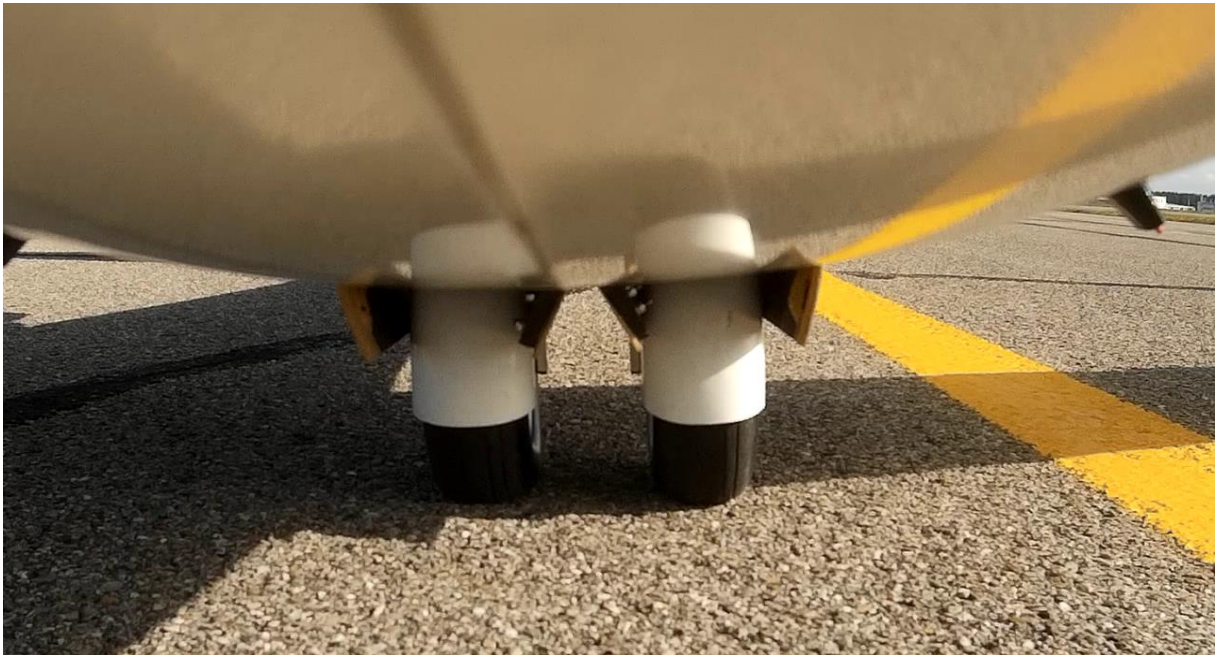
Figure 7 - Too soft tires deforming under normal load.

6. Change the main wheels to stiffer ones
 - a. Even though the gear was made stiffer, it was recognized that the tyres of the main gear are way too soft for the aircraft. This was discovered during one of the testing days, where the aircraft stood on the ground for a couple of hours. As a result, the foam-filled tyres deformed plastically and were not usable anymore. Additionally, during high-speed taxi tests a set of tyres burst into pieces after they got too hot (Due to braking and rolling). It was decided that a stiffer tyre is a must. And with no alternative tyres available for the same wheelset, a double sailplane tailwheel (TOST 150 MINI) instead of the original RC model grade wheels were bought. The TOST wheels would have a proper inflatable tyre mounted on, which would make the main gear stiffer laterally.

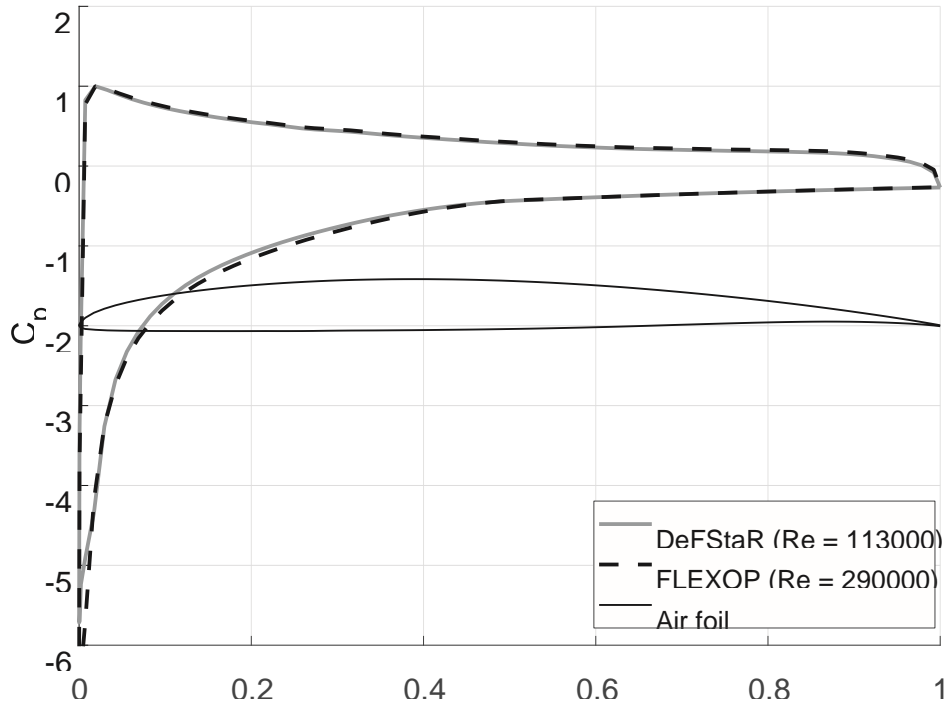
Figure 11- C_p -polars at 13° angle of attack.

The aerodynamic properties on configuration level were assessed using a model incorporating wing and fuselage in the software *XFLR5*. In order to assure similar flow conditions, the pressure distribution of the profile *try6* was compared at the different Reynolds-Numbers at which *T-FLEX* demonstrator and the *DeFStaR* subscale demonstrator were expected to stall (see Figure 11) using the program *X-FOIL* and no substantial deviations found.

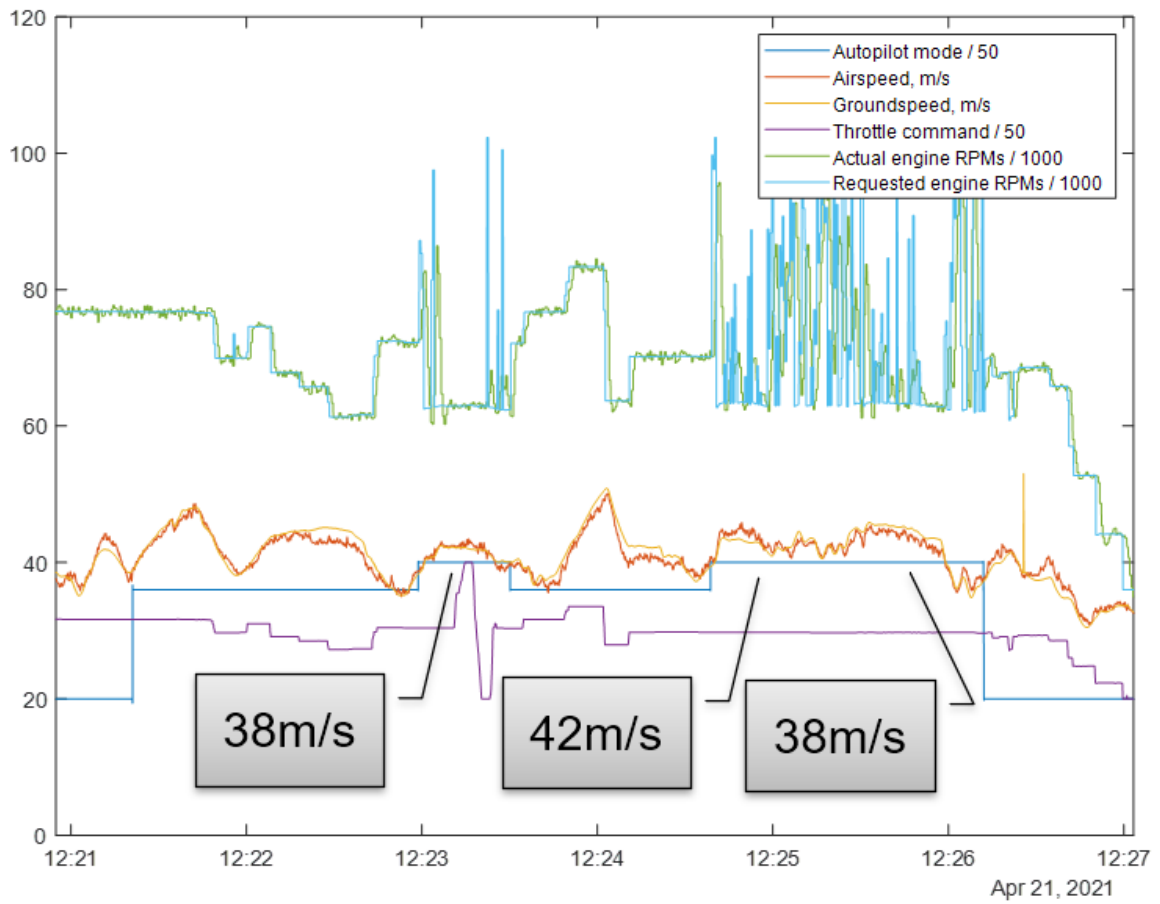
Figure 18 - Autothrottle testing during FT7. Two different speeds were used for the test. High frequency commands to the engine are visible.

The autothrottle segment was investigated. It was noted that the controller does not perform as expected. The engine control commands were very high frequency without allowing the engine to adapt (Figure 18). The effects can be seen in more detail in Figure 19. The module therefore required further adjustment.

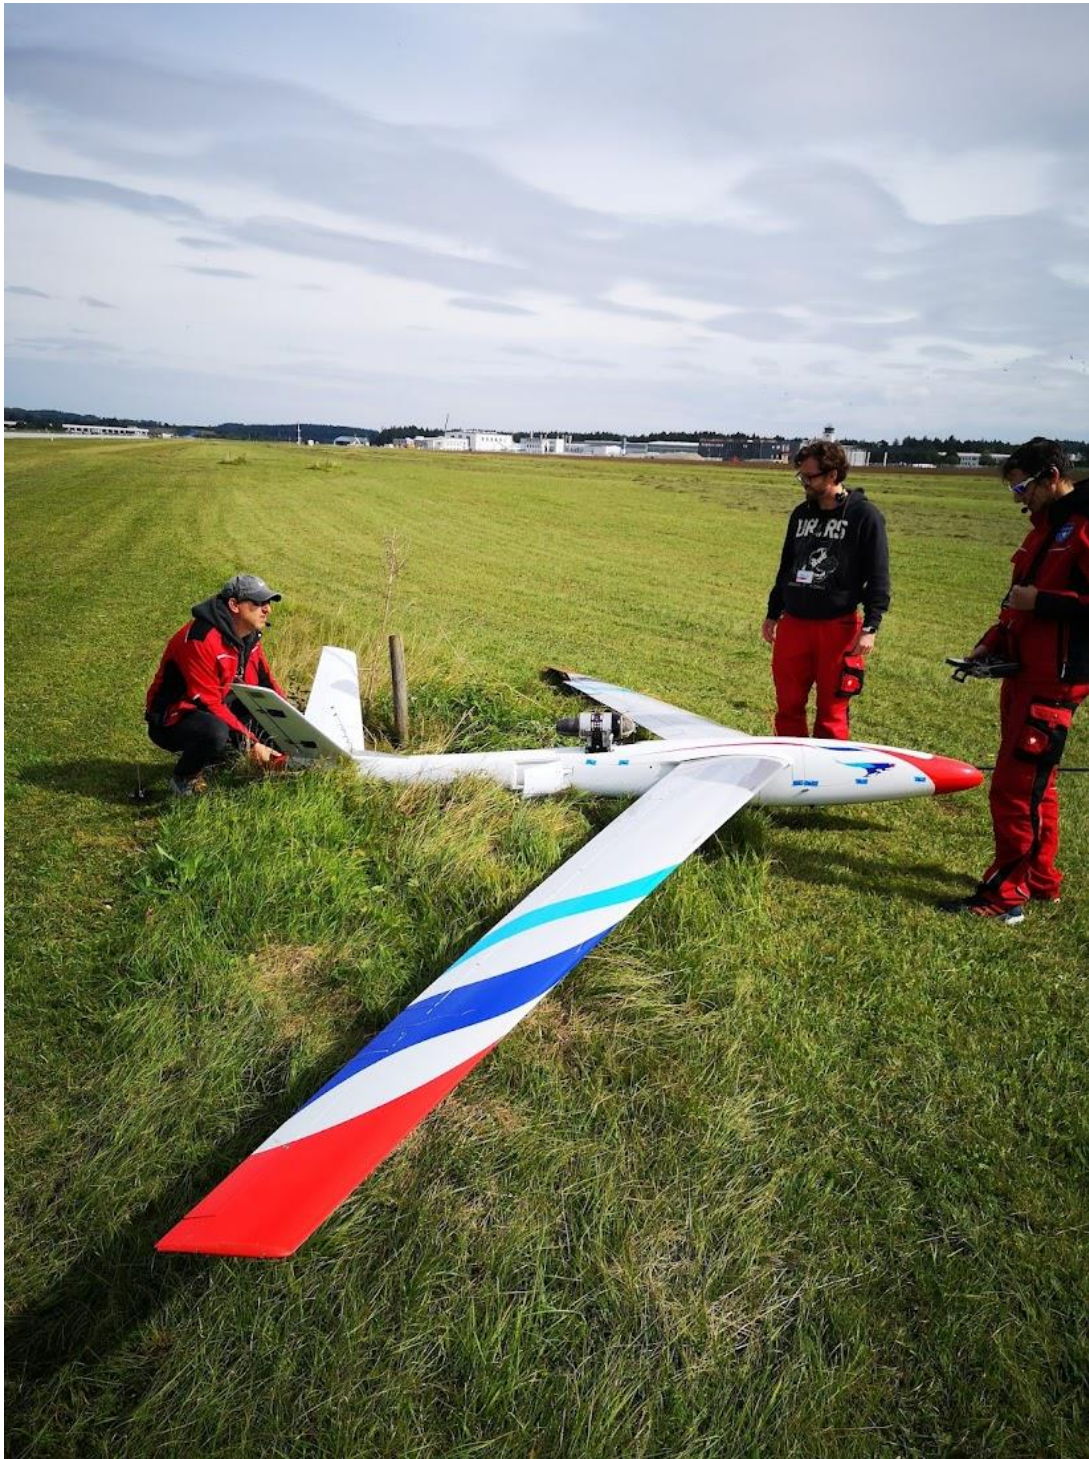
Figure 20 - The T-FLEX demonstrator after hitting the wooden pole during the FT8 take-off attempt.

Four flight attempts were made before the Flight Test 8 happened. Most of the aborted flights were due to smaller issues that were only discovered during the start-up on-field. For example, a servo was accidentally broken during the start-up procedure, or there was an issue with the engine. However, the fourth attempt resulted in damage to the demonstrator. During the take-off, the demonstrator uncontrollably went to the side and hit a wooden post off the runway (Figure 20). Many small damages were recorded: tailwheel assembly completely broken (Figure 21), one damper of the main gear, two flap control linkages and the left airbrake servo were broken. The air-data probe was bent.

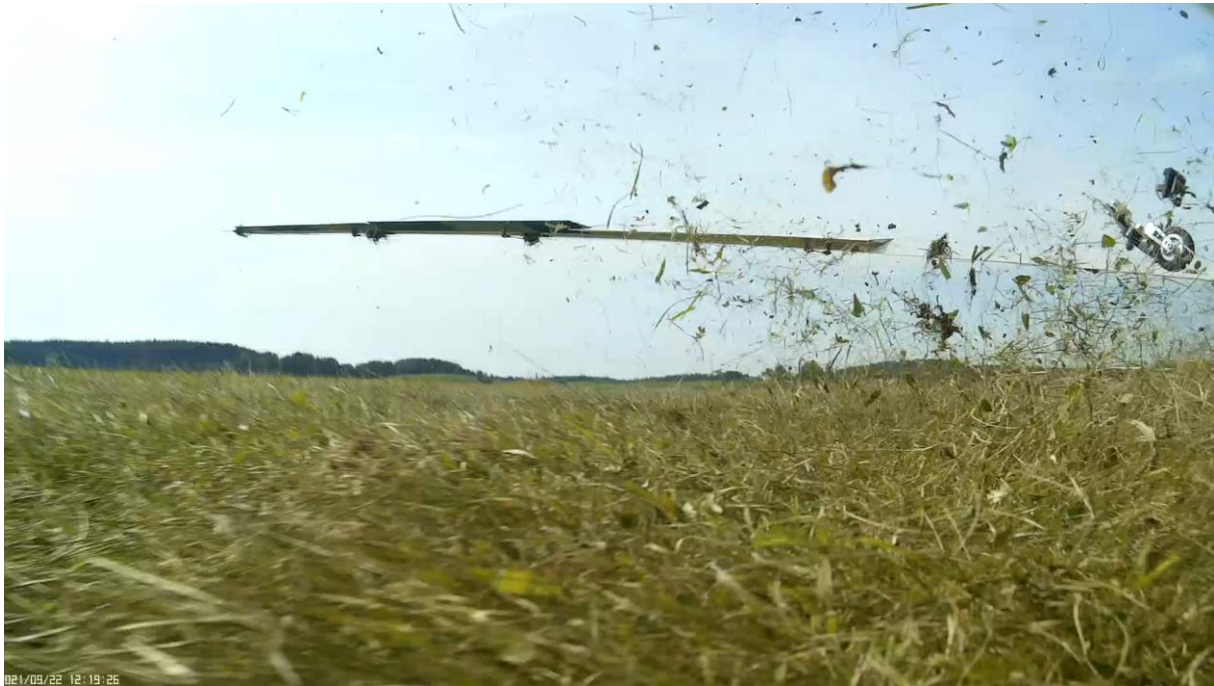
Figure 21 - Screenshot of the tailwheel detaching from the fuselage during the FT8 attempt.

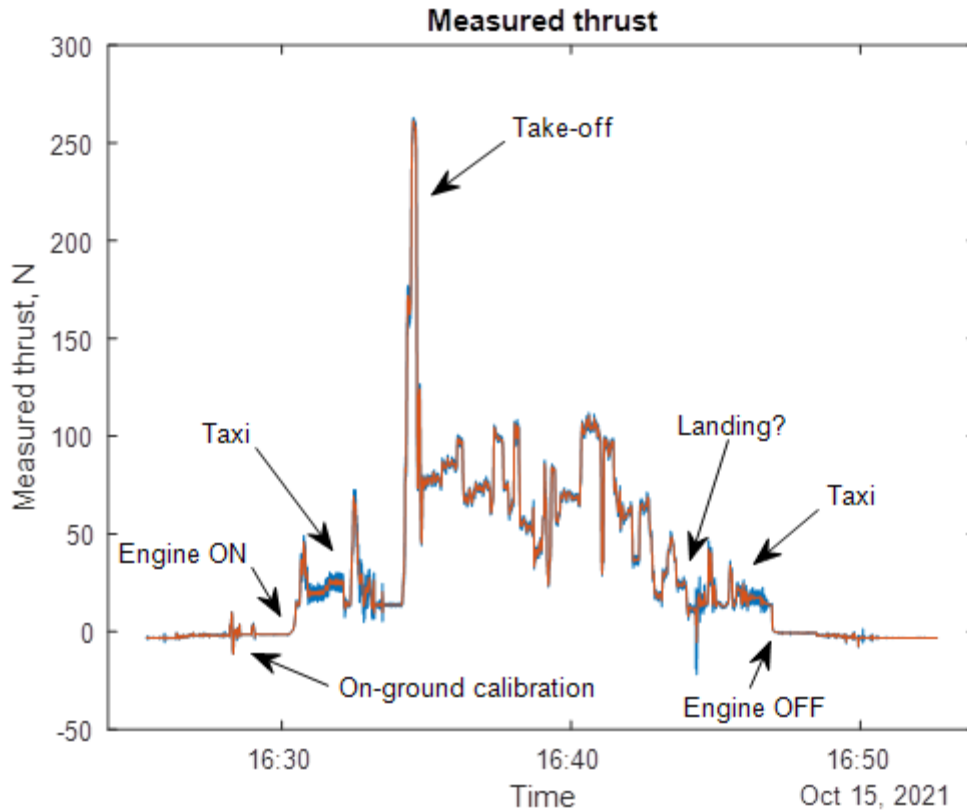
Figure 23 - Thrust Measurement System log during the FT8.

Unfortunately, the flight log was not captured properly. Due to a software bug and a human mistake, the log was accidentally deleted right after the flight, in preparation for the next one. All attempts to recover the log failed. Only video material, screen recordings of the GCS, the telemetry log (Figure 22) and the data from thrust measurement system (Figure 23 - Thrust Measurement System log during the FT8.) remained.

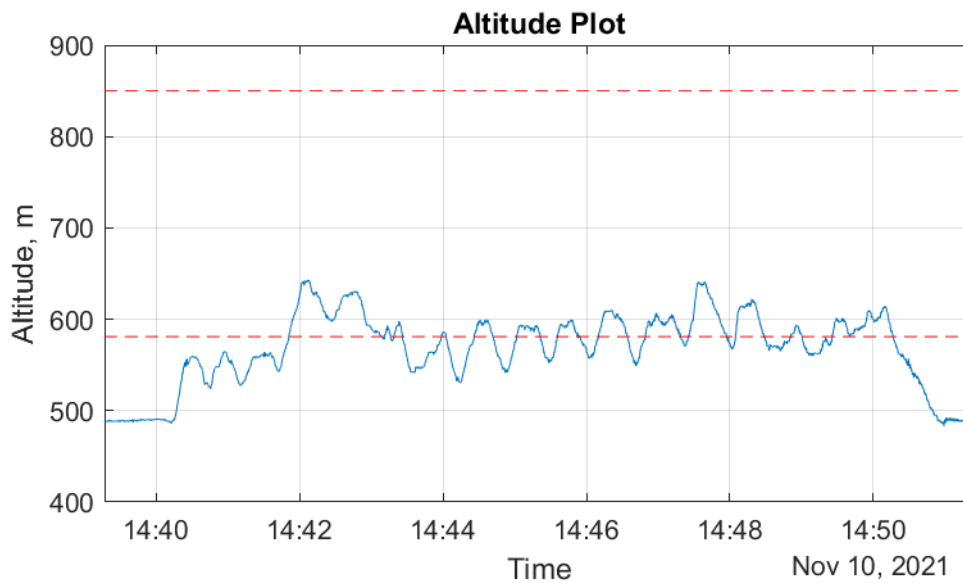
Figure 25 - Altitude plot fo the FT9.

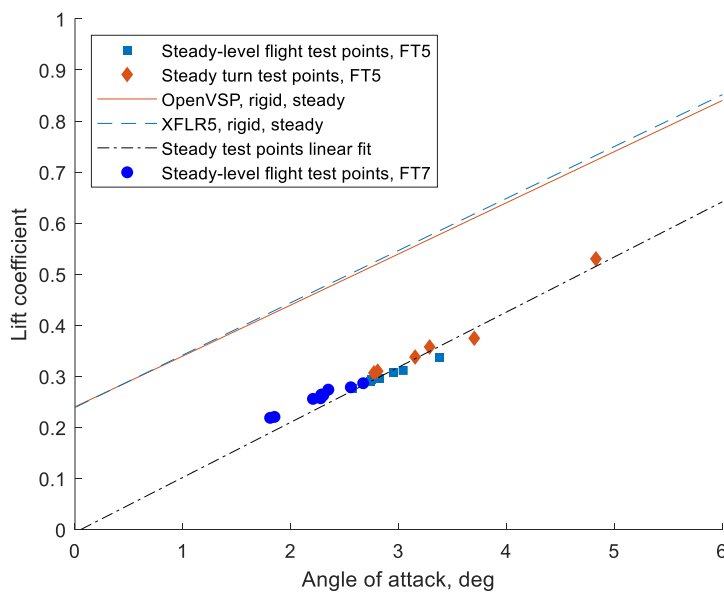
Figure 27 - Lift comparison (theoretical and in-flight data).

To check for consistency in between the previous flight test campaigns, analysis of the FT7 was done. Lift curve was investigated for clean configuration. Steady-level flight points were extracted from FT7 and compared to steady-level flight points and steady turn points from FT5 (Figure 27). Furthermore, theoretical estimation of the lift curve was added.

- Lift curve as measured in-flight did not correspond to the theoretical estimations made by XFLR5 [6] and OpenVSP [7] software. An almost constant lift coefficient offset of around 0.2 can be observed which results in 35-45% lift loss in the 2-4deg angle of attack region.
- FT5 and FT7 data do align in the same trend.

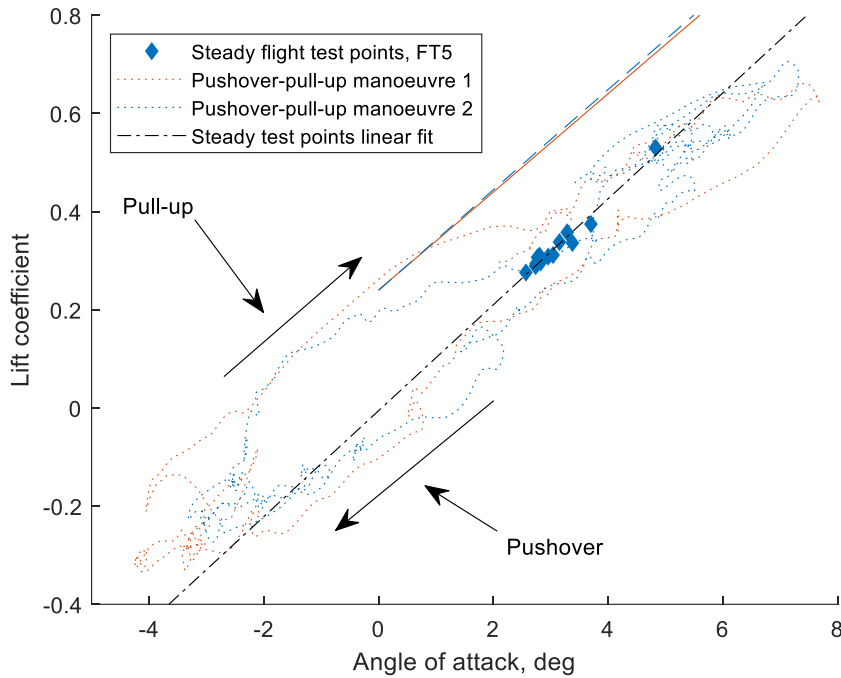
Figure 28 -Change of lift coefficient during pushover-pull-up manoeuvres.

Unsteady lift coefficient curves from pushover-pull-up manoeuvres from FT5 were also compared (Figure 28).

It was noted that the lift coefficient values during the pull-up do match the theoretical predictions, while during pushover they fit in the same offset as the steady state manoeuvres. This could be an indication that the flow is indeed separated on a big part of the wing already at low angles of attack and it gets reattached during a pull-up.

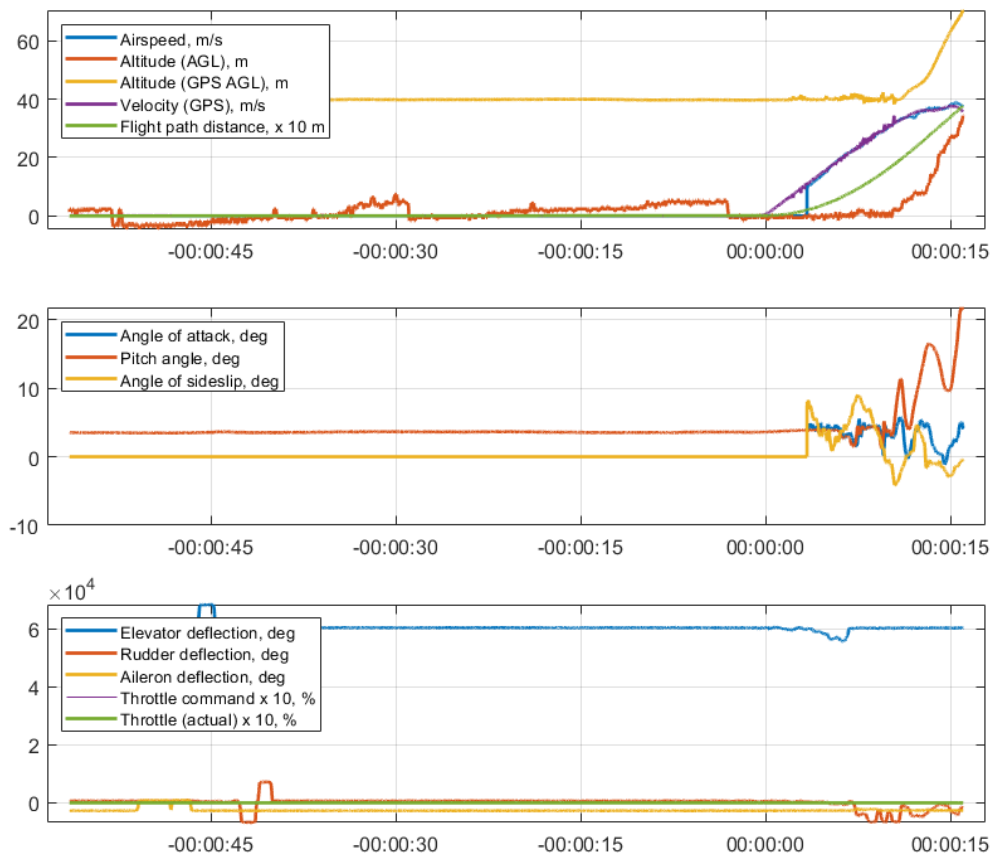
Figure 29 - Take-off data from Flight Test 7.

To better understand the bad take-off performance of the aircraft, detailed analysis of each take-off was done. Relevant data was plotted (Figure 29 is an example from FT2) and specific take-off run points extracted. These points were summarised in Table 7.

What can be noted in the take-off data is that the lift-off airspeed, taken at 5m AGL is way higher than the design airspeed (34m/s vs 24m/s, or 42% higher). This might point to the same loss-of-lift problem as discussed in previous section.

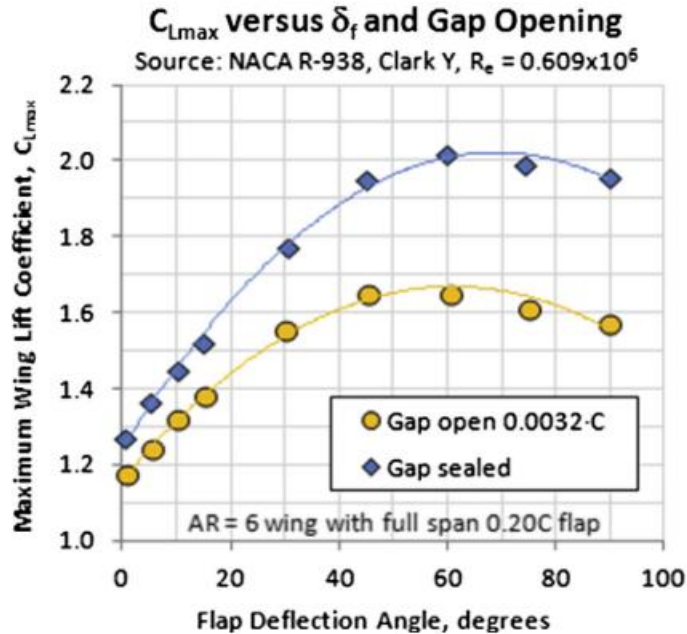
Figure 30 - The effect of gap on the magnitude of maximum lift coefficient [8].

It was contemplated that the gaps in between the flaps, which are not covered in the case of T-FLEX, might be the reason of pressure loss on the lower side of the wing. Such effect was noted by [8] (Figure 30).

From Figure 30 big amount of lift can be lost due to the untreated flap gaps. However, this effect is mostly present at big angles of attack and increases with increasing the flap deflection. The loss is also in a lower order of magnitude than we expect. Therefore, it was decided, that even though this effect could play a role to recover the lift for T-FLEX, it probably is not the main problem.

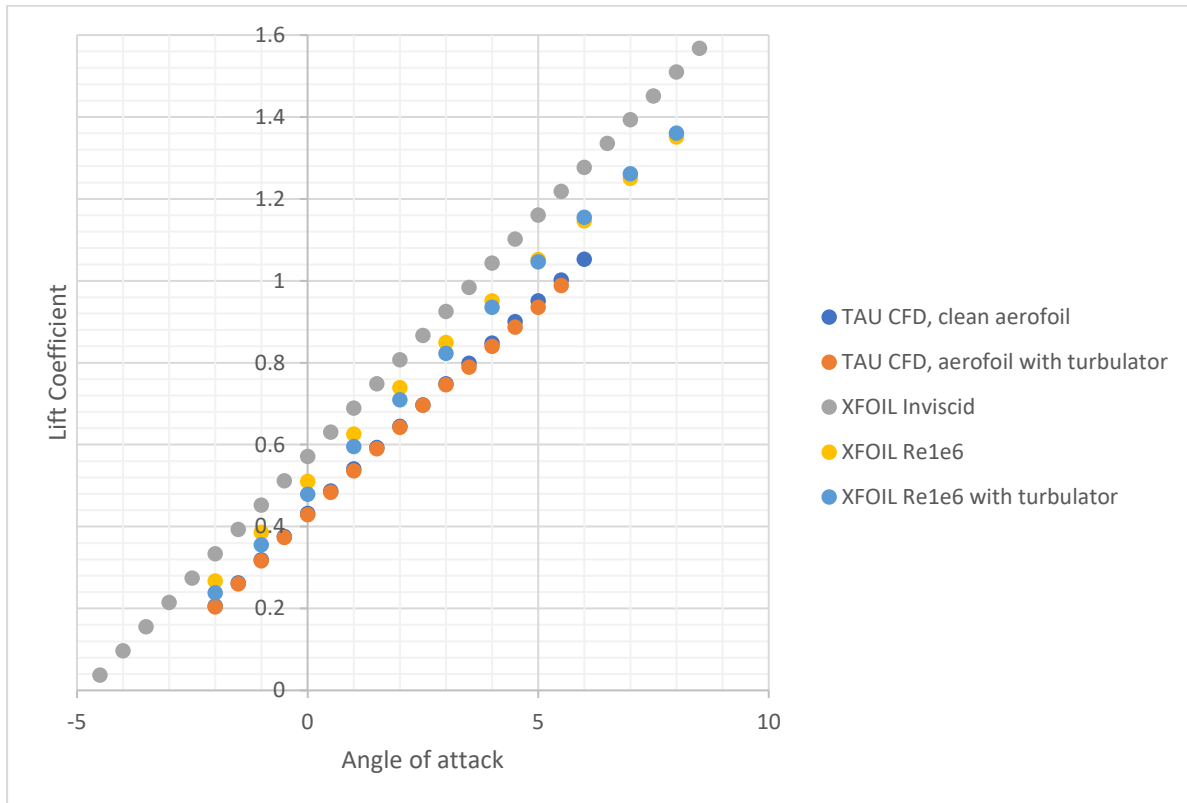
Figure 32- Comparison of coefficient of lift with and without the turbulator.

2. The change of the forced transition location does have an influence with XFOIL code. The difference in between the cases with and without the turbulator is in the order of $\Delta C_L = 0.05$.
3. XFOIL does calculate higher lift than the TAU code.
4. Inviscid solution predicts a way higher lift than either XFOIL or TAU code. The difference is in the order of magnitude of $\Delta C_L = 0.10 - 0.15$.

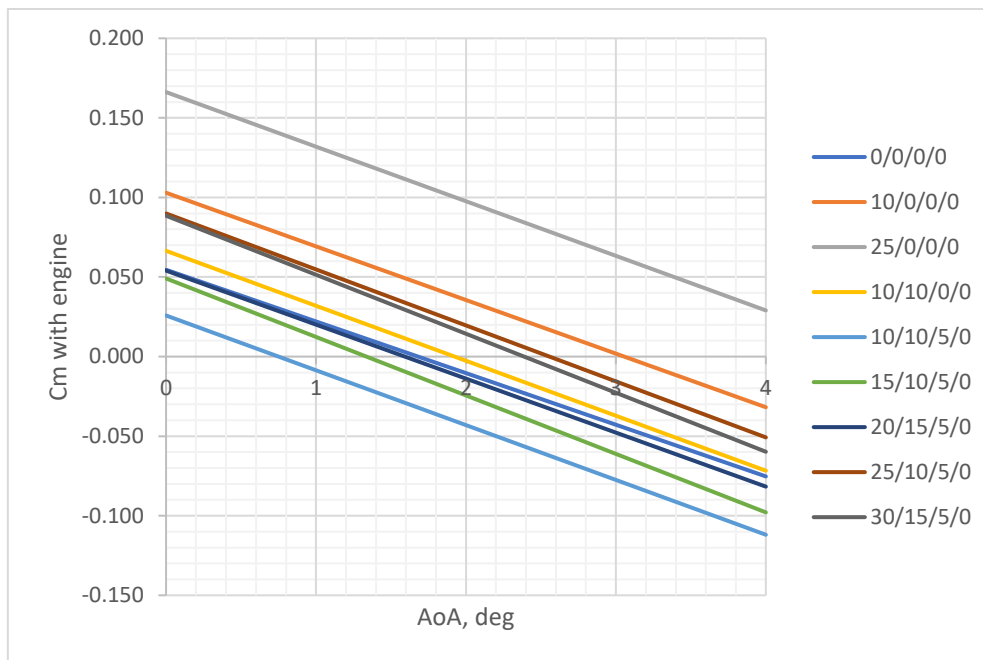
Figure 35 - Moment coefficient for different flap settings with the full thrust effect included.

After analysing all the flap configurations, it was noted that the single flap deflection produced significant pitching moment. This was also noted during flight, where the trim had to be significantly different from the cruise configuration (marked with 0/0/0/0).

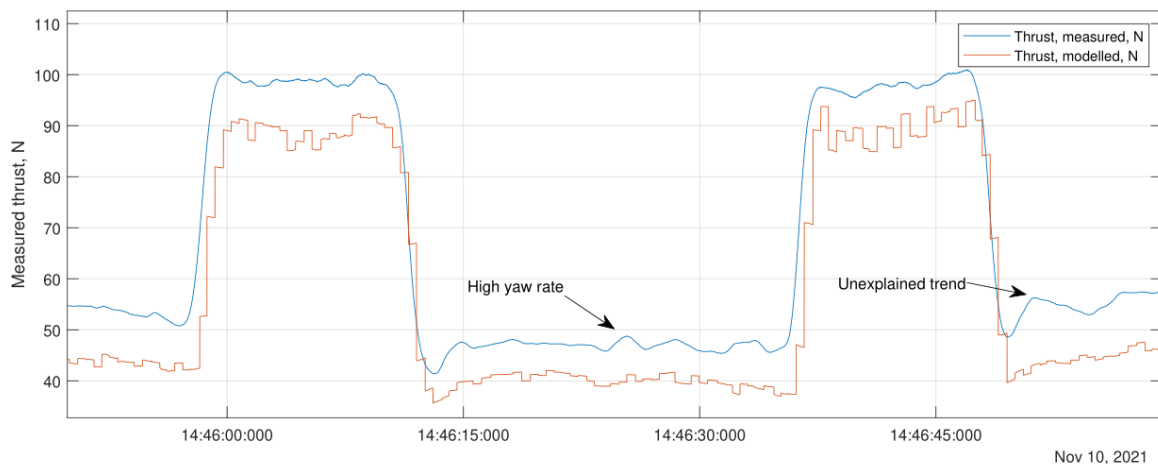
Figure 37 - Measured thrust during a throttle step input.

An extract of two throttle step inputs is shown in Figure 37. The lower sampling frequency of the engine revolutions, in comparison to the rest of the flight variables, can be noted. However, the thrust measurement system does follow changes in the engine spool speed well.
